**LUCENT  
HOME  
INSPECTIONS**

## Home Inspection Report

1234 Sample Inspection Rd., Eureka, Illinois 61530

170904.10

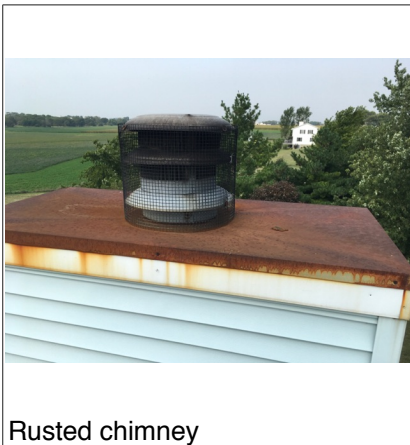
Rusted chimney

Comments Recommend painting steel chimney cap as a part of preventative maintenance.

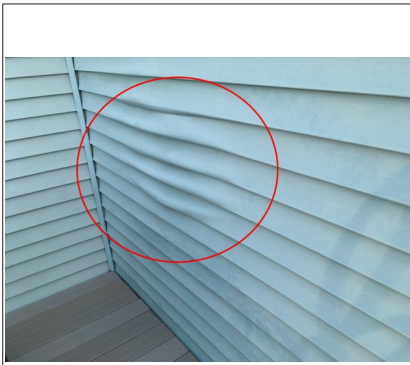
Siding warped from excessive heat by grill sitting on deck.

Comments Siding had some damage (holes and cracks on multiple sides of the home), recommend repairing/replacing damaged sections to prevent water penetration into the home.

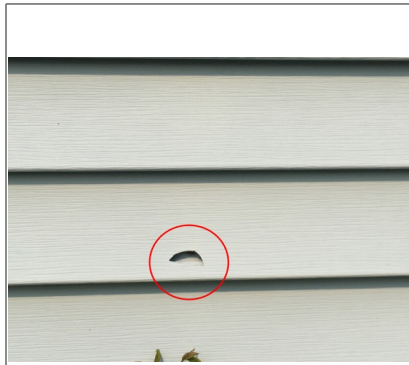
Example of cracked hole in siding

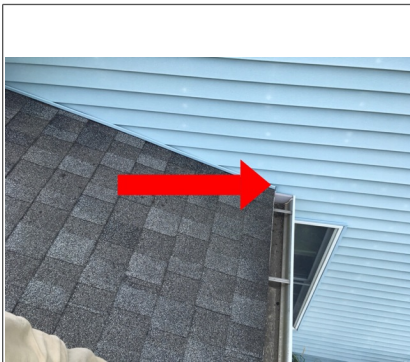
**Comments** Kick-out flashing is not present on the home as was typical for this generation of homes. While no damage was visible on the day of inspection, it is recommended that a contractor repair at some point in the future to prevent possible moisture penetration and damage.

Kick-out flashing not present

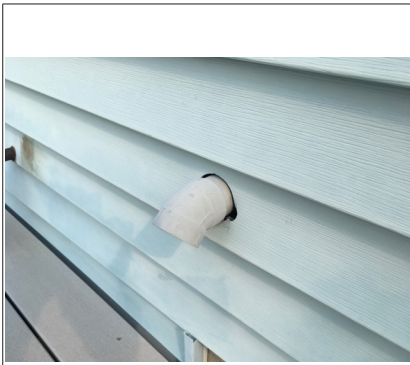
Example of utility penetration needing caulk

**Comments** Recommend caulking at utility penetrations.

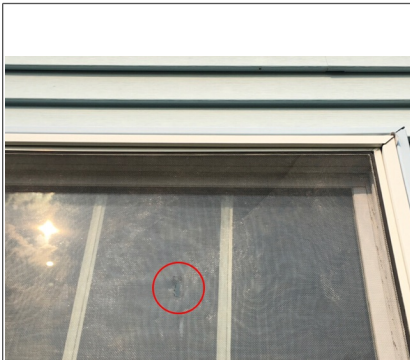
Example of a torn and bent screen (garage window)

**Condition**  Satisfactory  Recommend repair/replace damaged screens

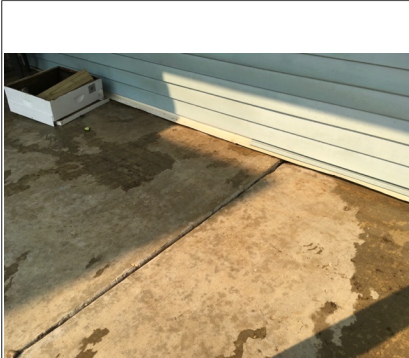
**Comments** Uneven slabs in walks, could be a tripping hazard, recommend repair and/or replace at some point in the future.

Uneven slab on porch

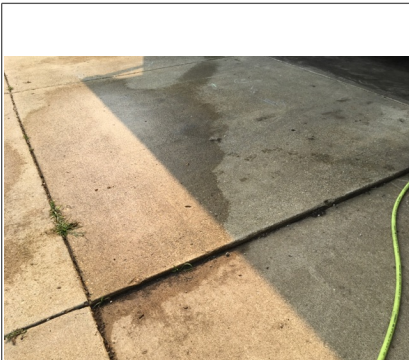
Uneven slab on driveway

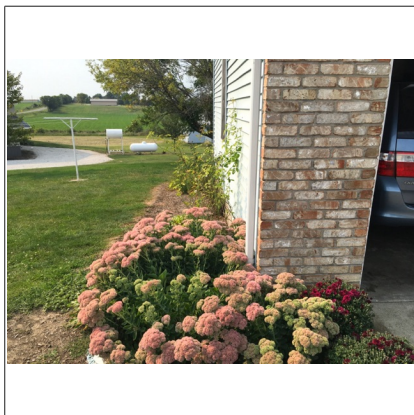
**Comments** Recommend improving grade around foundation perimeter to improve water drainage away from the foundation and moisture penetration into the home.

Recommend trimming trees/vegetation so it doesn't come into contact with the home.

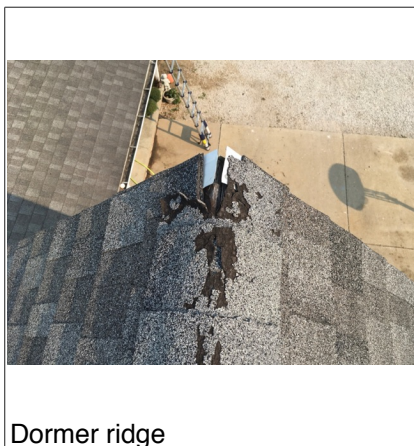
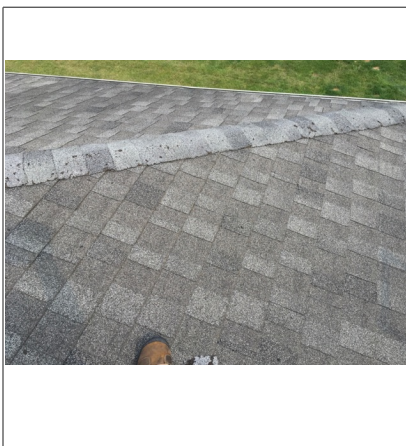
Dormer ridge

Comments Roof appeared to be nearing the end of it's useful life; the dormers have OSB exposed at the ridge in places and shingles are missing in places throughout the roof - recommend a licensed and professional roofing contractor evaluate and repair soon.

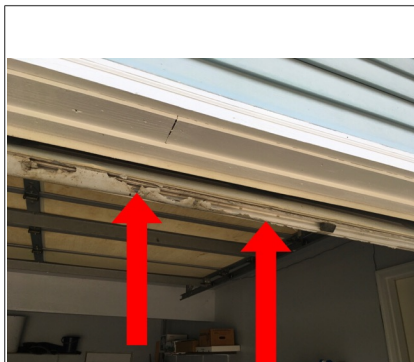
Weatherstripping is damaged on garage door

Comments Weatherstripping on garage door is damaged and missing in places, recommend repair by a handyman.

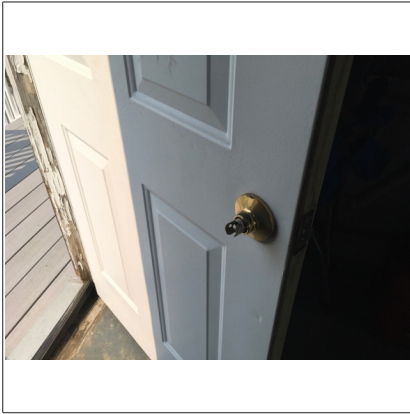
Comments Exterior handle is missing on garage service door, needs replacement.

Paint is peeling on garage service door, recommend repainting or wrapping with aluminum.

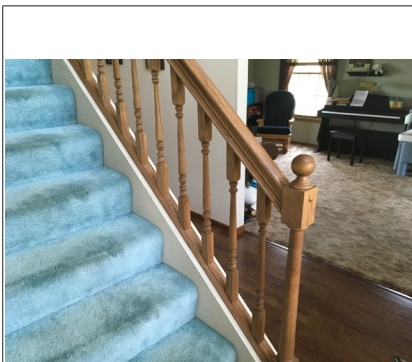
Main stairway balusters

**Comments** Balusters are too far apart on main stairway leading from first floor to second floor, for additional safety recommend balusters be a maximum of 4" apart - safety concern for small children.

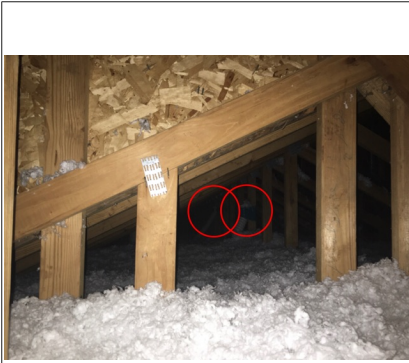
**Comments** Bathroom exhaust fans are not vented to the exterior (typical for this generation of homes). While no damage was visible on the day of inspection, this could cause moisture in the attic and deterioration of structural members, recommend repair at some point in the future by a professional contractor.

Two bath fans not vented to the exterior

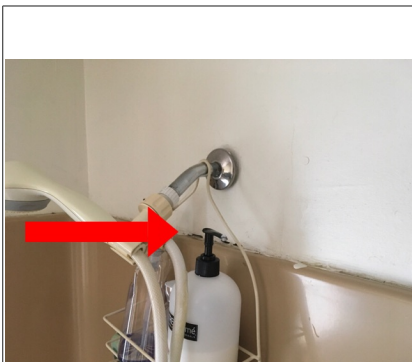
Caulking needed on shower in master bathroom

Recommend caulking shower in master bathroom.

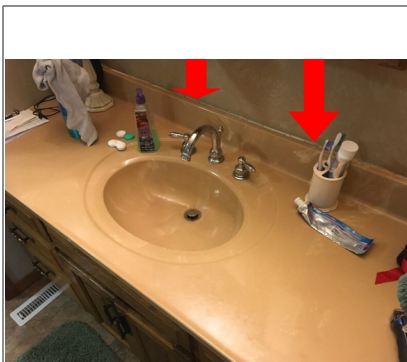
Loose countertop/bad caulk joint

**Comments** Countertop is loose on master bathroom vanity, recommend repair by a handyman or carpenter (re-caulk joint between countertop and wall after fixed).

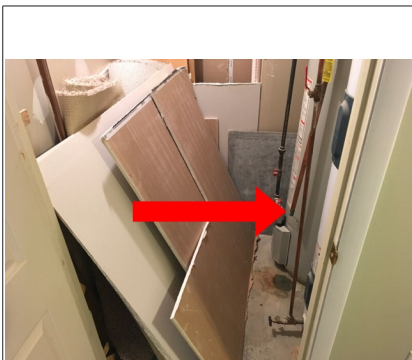
TPR valve not extended far enough on State water heater

Temperature-pressure relief valve extension should be 4"-6" off of the floor, safety concern, recommend a licensed plumber repair.

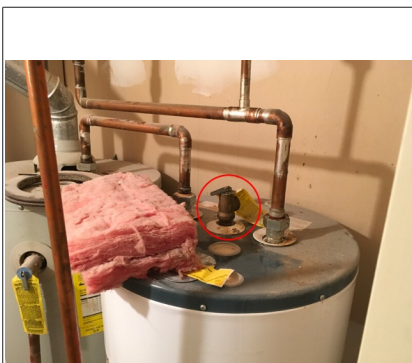
TPR valve

Temperature-pressure relief valve should have an extension extending to 4"-6" off of the floor, safety concern, recommend a licensed plumber repair.
